QWL 3.0 Transient Voltage

TCS Technical Bulletin

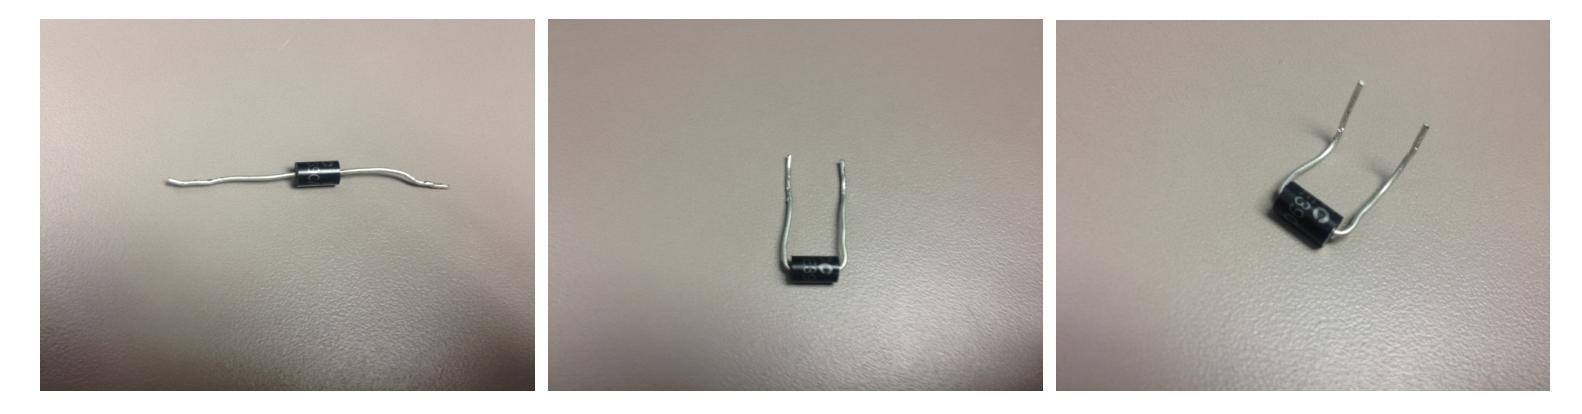
The 24V relays inside the QWL 3.0 panel are connected to a high voltage relay or contactor. When the QWL3.0 panel relay opens, the coil of the high voltage device (recently had a voltage applied to it) has a magnetic field that starts to collapse. The collapsing magnetic field inside the coil generates a large voltage which is applied across the relay contacts inside the QWL3.0 panel. When the large voltage spike from the collapsing magnetic field reaches the gap created by the opening of the QWL3.0 panel relay, it radiates outward. The radiating electromagnetic waves created at the relay contacts interfere with the USB ports causing them to lock up, thereby disabling communications with the TCS wired and wireless networks.

3. Form the TVS diode as shown below. It does not have a polarity.
